TECHNICAL BULLETIN APTB-02/08 R2

6.0L Injector Failure Analysis and Preventive Maintenance

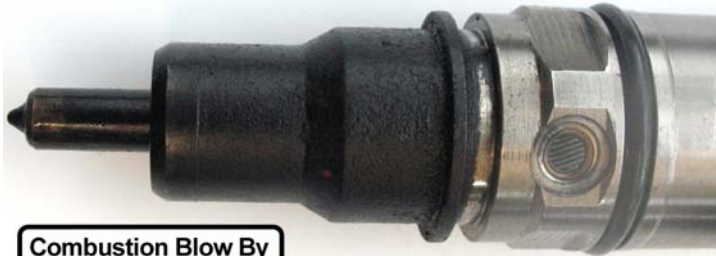
An injector nut that's black with carbon from the chamber gasket to the bottom o-ring, indicates that the sealing surface of the injector sleeve needs to be cleaned. We recommend using solvent and a stiff brush (e.g., Rotunda / Owatonna Tool part number 303-D112) to loosen and remove carbon materials, paying particular attention to the chamber gasket and injector o-ring sealing areas, then use shop towels to clean and dry the sleeve.

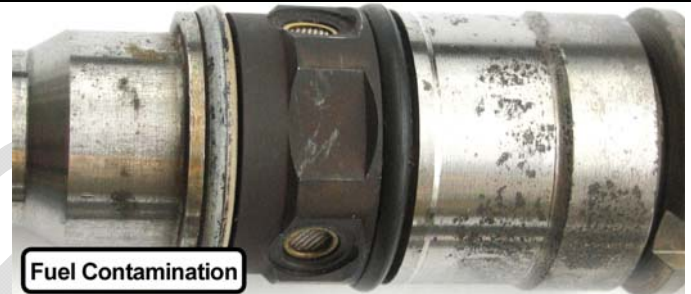
Discoloration, or other visible signs of fuel contamination, in the area between the two injector nut o-rings indicates that the injector has been subjected to water, or other contaminants in the fuel. The fuel should be analyzed to determine if contaminants are currently present (the contaminated fuel that left the evidence may already have flowed through the system). If contaminants are present, a complete flushing of the fuel system is required.

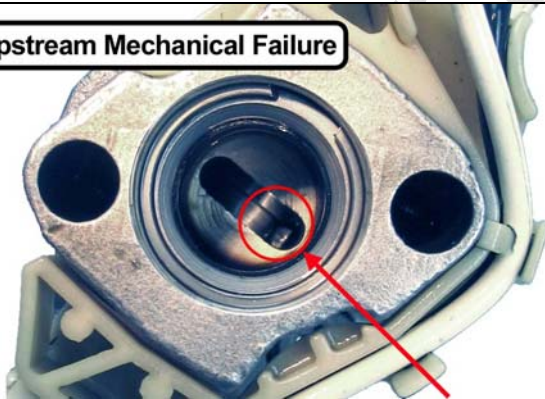
Upstream Mechanical Failure

Metallic pieces in the high pressure oil inlet bore of the injector (note the chunk restricting movement of the spool valve) is a sign of a parts failure upstream from the injector, most likely the high pressure pump. Replacement of the high pressure pump and oil reservoir screen, plus flushing the high pressure oil system will be necessary.

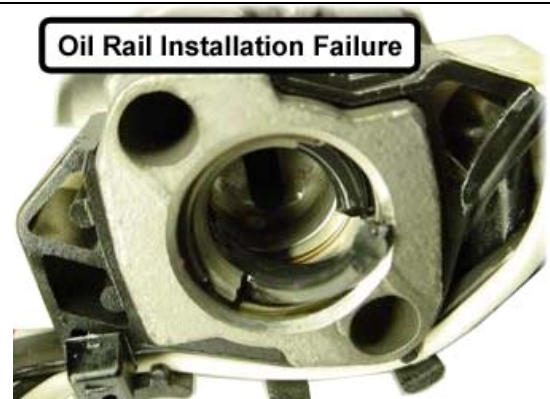
Oil Rail Installation Failure

Misalignment of the oil rail inlet fittings can result in a failure such as shown above. The seal itself can be damaged by misalignment, even without evidence of hard part failures. To avoid this type of failure, be certain that all injector inlet fittings are properly aligned during oil rail installation.
