WARNING

Avoid Premature, Non-Warrantable Turbo Failures!

Attention Cruze and other owners of GM 1.4L LUV Engines

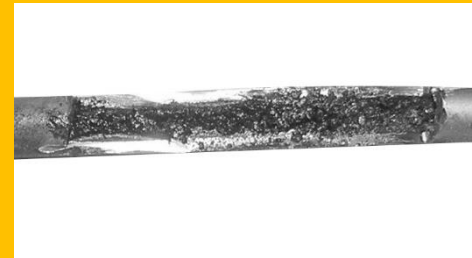
While failures of the turbocharger utilized by the Chevy Cruze 1.4L LUV Engines are often attributed to a variety of issues, our engineers have determined that most failures are commonly related to restricted oil feed lines and contamination from reused installation (banjo) bolts.

Due to the location of the oil feed line near the exhaust manifold (which is utilized for cooling and lubrication) on GM 1.4L LUV Engines, it is common for the oil to “cook” or “solidify” within the line and installation bolts when the engine is abruptly turned off.

Please see the image provided for an example of these “clogged” oil lines commonly found on a failed turbocharger from these engines.

- 1. When replacing a previously failed turbocharger on this application:**
Always Replace your oil feed line and installation bolts (included with new oil feed lines) to ensure your new product is getting proper lubrication. *Lack of lubrication can and will result in premature failure of your new product and result in a denial of a warranty claim.*
- 2. Check your gaskets!**
This new turbocharger does not come with the necessary gaskets needed for reinstallation! *Improper seating from bad gaskets can lead to oil leaks causing less lubrication and cooling for this turbocharger.*
- 3. Change Your Oil!**
Most turbochargers utilize oil for lubrication and cooling. A fresh oil change can help you get the most out of your new product by ensuring proper operation.
