# NEW! HEAVY-DUTY TURBOCHARGER: FOR ON-HIGHWAY 550 H.P. 3406E OR C15 ENGINES

## INTRODUCING THE NEW COMPRESSOR COVER WITH GT4702 UPDATES!

## INTRODUCING THE NEW HEAVY DUTY TURBINE HOUSING

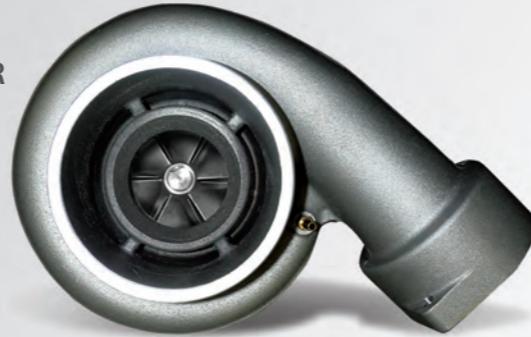
The GT4702 uses a boreless compressor wheel for cycle fatigue durability. However, the older compressor cover design causes premature blade failure, that in turn, causes catastrophic turbo failure and negatively impacts component salvage.

The example below shows three symmetrically spaced inducer support ribs for inducer bleed. These produce blade harmonics that cause premature wheel failure and compressor housing damage. Due to the common failure mode the three web inducers cause, it is not recommended that this compressor cover be reused.

The new assembly shown above, contains four asymmetrically spaced inducer support ribs to eliminate the compressor blade and wheel frequency problems.

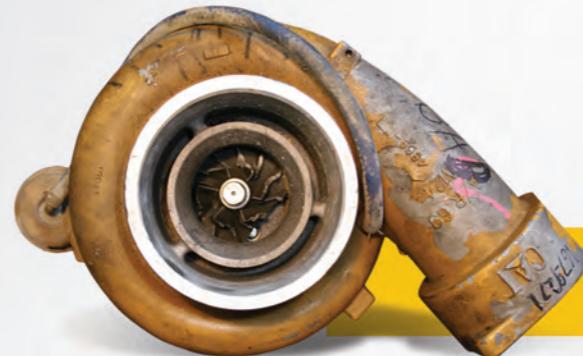
High exhaust temperatures can cause the turbine housing divider wall to begin to crack and run the possibility of escaping visual inspection on an external assembly examination.

To the right, a turbine housing divider wall has been cut to reveal a series of cracks, that can cause turbo failure due to foreign object damage of turbine housing fragments entering the turbine wheel inducer.

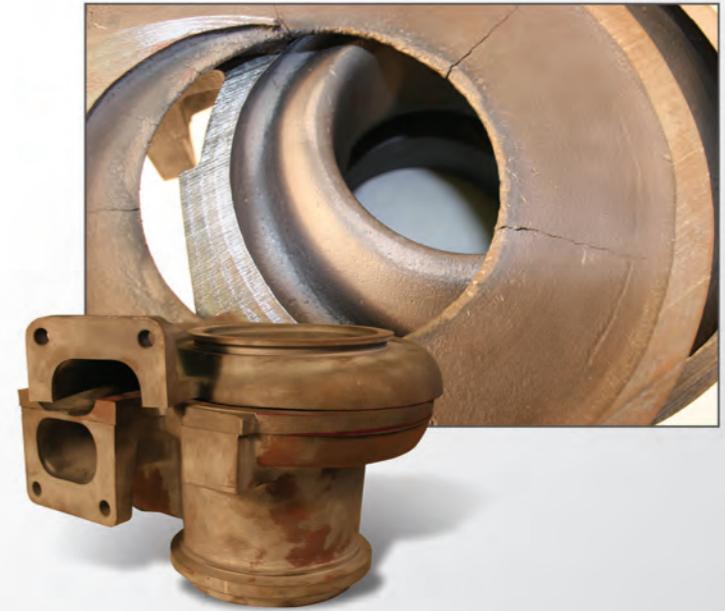
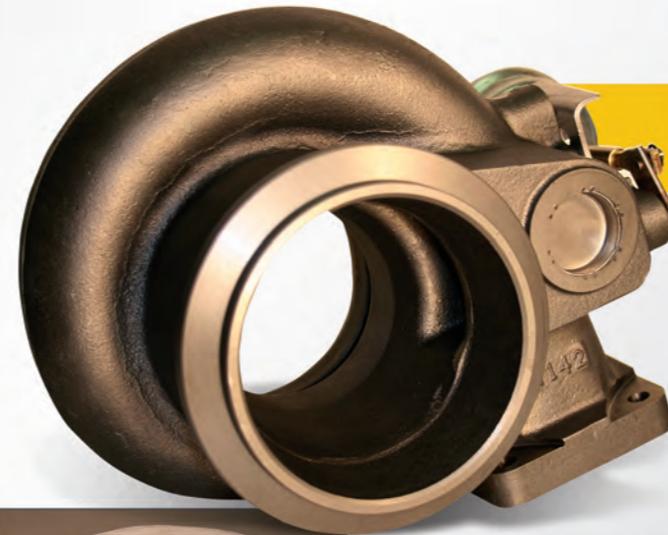
The "New" Heavy-Duty Turbine housing has been designed for strength. In addition to advanced material selection, a critical element, the divider wall has also been designed to be thicker without change to the turbine A/R ratio by keeping the cross-sectional area of the gas passage the same as the original design.

The cut-a-way sections to the left demonstrate the old Caterpillar turbine housing cross-section, versus the new Heavy Duty version cut in the exact same coordinates.

The new "HD" turbine housing boasts the new stronger divider wall thickness.
